Manhole Inspection Summary

Manhole # S17K__003MH

Insp Date: **4/10/08 12:30 PM**

Location Address: **2401 frederick-ashton shopping center** Cross Street: **warwick st**

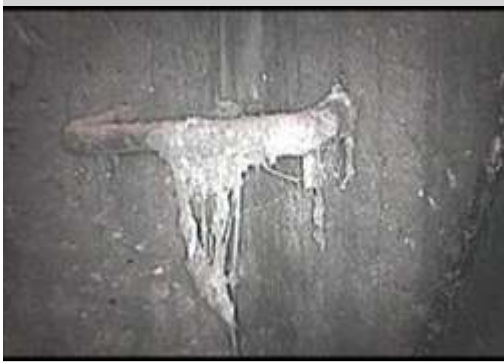
Defect 3

Surcharge ☒ **Evidence Of Surcharge** Depth: **3** (ft.) ☐ Active Surcharge Present

surcharge evidence

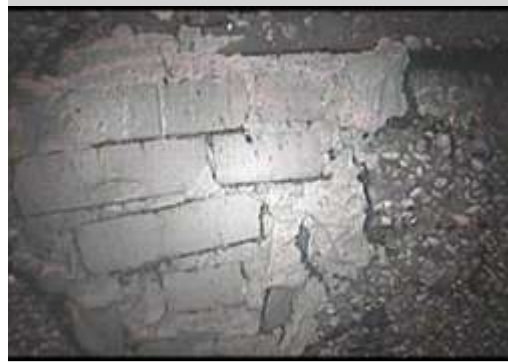
Defect 2

Barrel Material: **Concrete** ☐ Parged
Shape: **Circular** Diameter: **48** (in.) Length: **0** (in.)
Condition: ☐ Sound ☐ Cracked ☐ Root Intrusion ☐ Loose Brick ☒ **Deteriorated**
Infiltration: ☒ None ☐ Joint ☐ Cracks ☐ Mortar ☐ Roots ☐ Wall

deteriorated concrete barrel wall repaired with brick and mortar

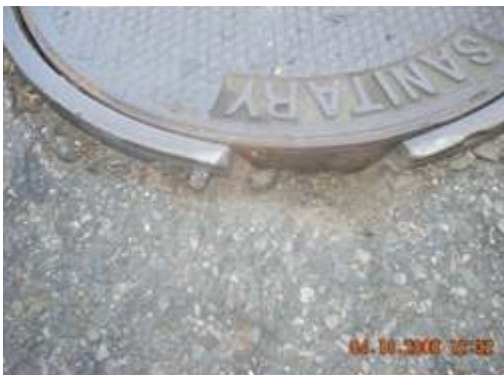
Defect 1

Frame Offset: **0** (in.) Condition: ☐ Sound ☒ **Cracked** ☐ Leaks

broken frame

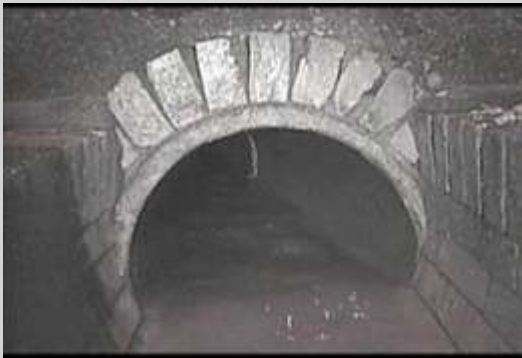
12 O'Clock Outflow

Pipe Height: **14.4** (in.) Rod and Bar (Angled)
Pipe Material: **Clay** ☐ Pipe Lined
Invert Depth: **17.83** (ft.) Flow Characteristics: **Slow**
Deposits: ☒ None ☐ Mud ☐ Sludge ☐ Debris ☐ Grease
Silt Depth: **0** (in.) Deposits Extent:
Infiltration: **None** Pipe Seal Cond: **Sound**

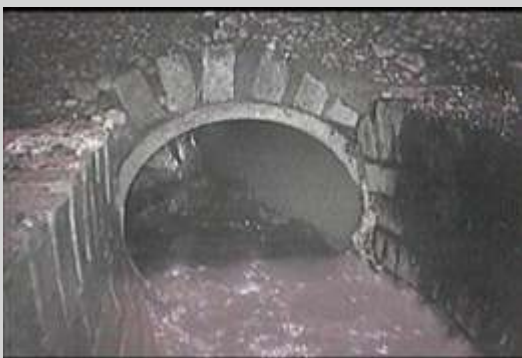
6 O'Clock Inflow

Pipe Height: **14.4** (in.) Rod and Bar (Angled)
Pipe Material: **Clay** ☐ Pipe Lined
Invert Depth: **17.72** (ft.) Flow Characteristics: **Slow**
Deposits: ☒ None ☐ Mud ☐ Sludge ☐ Debris ☐ Grease
Silt Depth: **0** (in.) Deposits Extent:
Infiltration: **None** Pipe Seal Cond: **Sound**

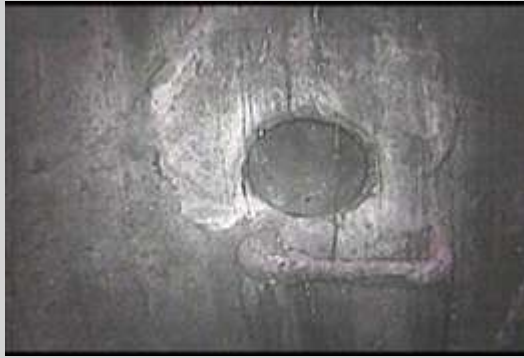
9 O'Clock Inflow

Pipe Height: **6** (in.) Rod and Bar (Angled)

Invert Depth: **9.13** (ft.) Flow Characteristics: **None**

Pipe Seal Cond: **Sound**
